**PROPOSED REMEDIAL ACTION PLAN**  
**3456 Oneida Street**  
**State Superfund Project**  
**Town of New Hartford, Oneida County, New York**  
**Site No. 6-33-049**  
**February 2010**

3456 Oneida Street

State Superfund Project

Site No. 6-33-049

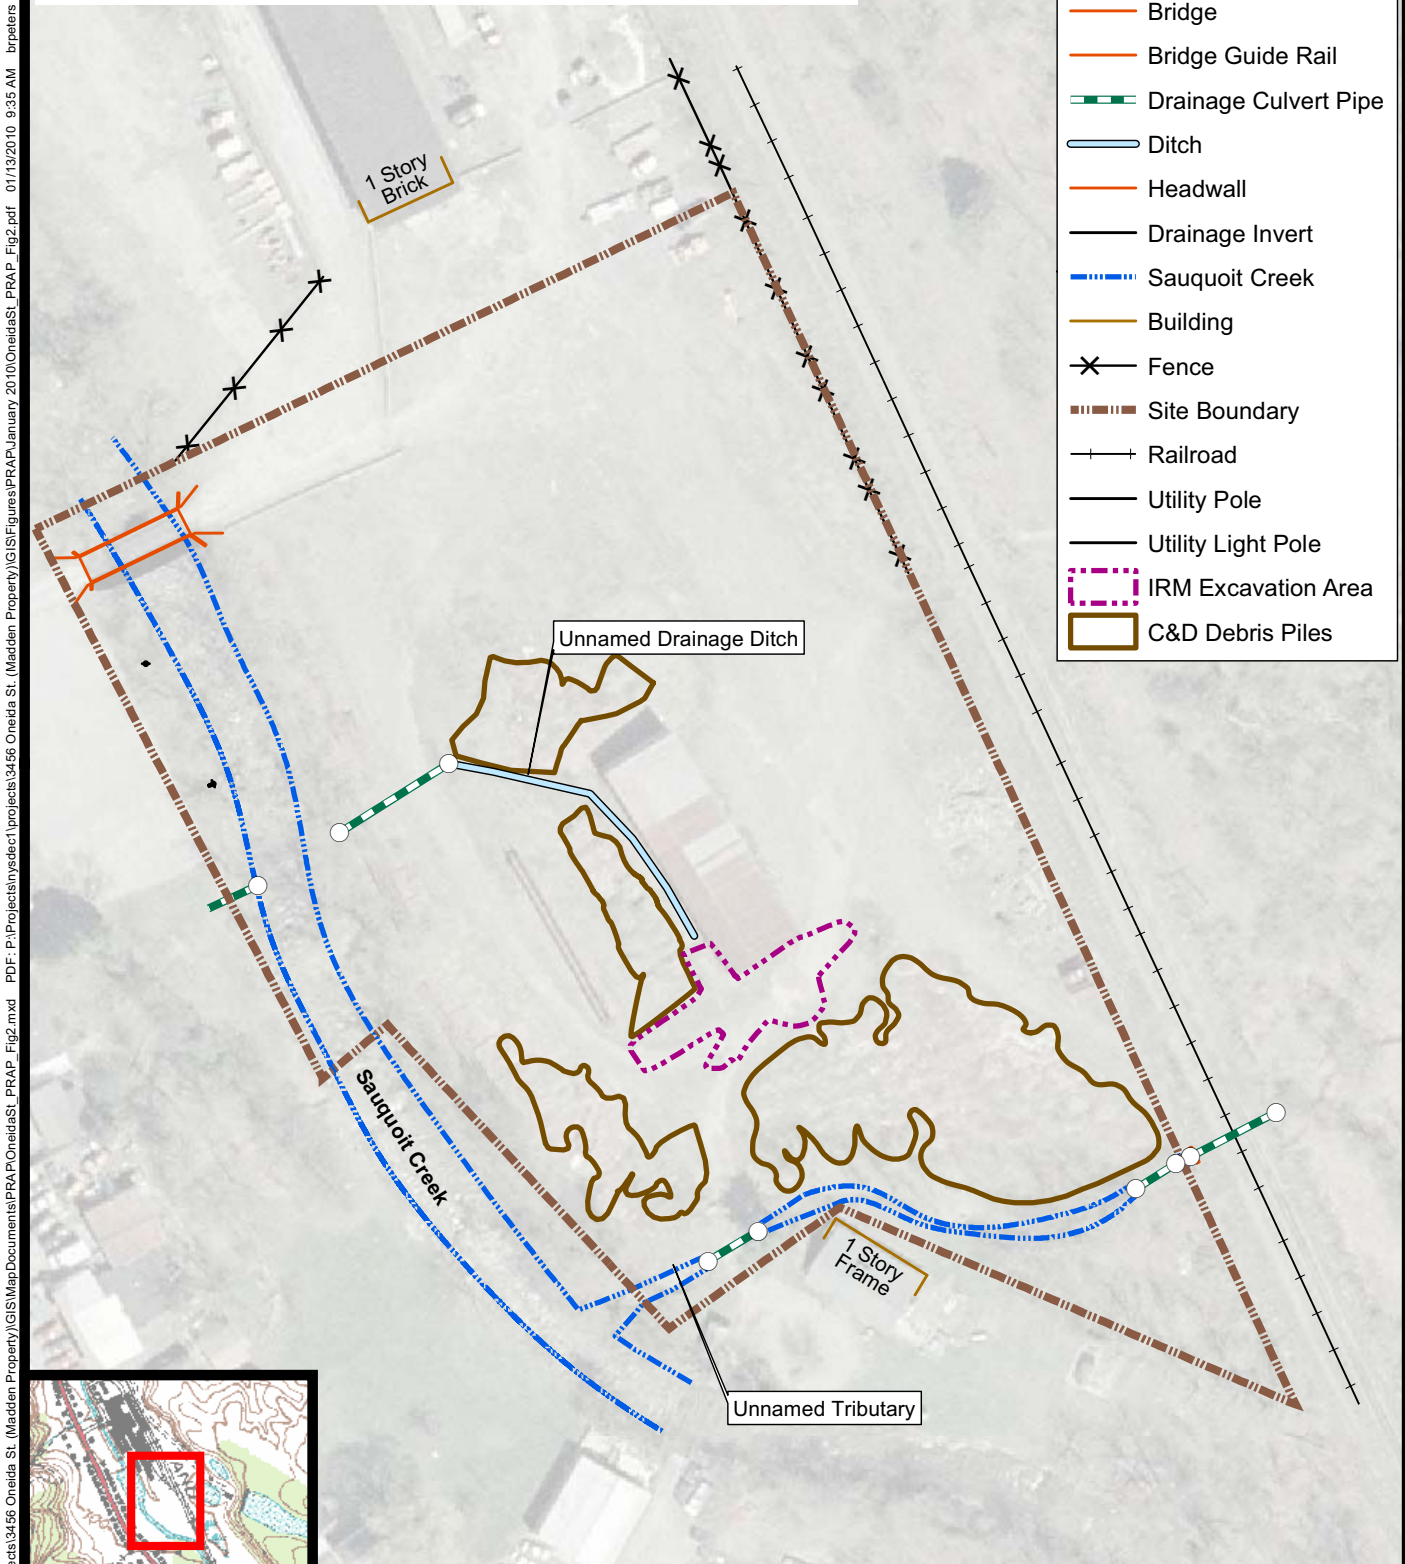
Figure 2 presents an aerial photograph of the site showing the site boundary, elevation contours and primary surface water features. The primary surface water feature at the Site is Sauquoit Creek, which flows northerly and acts as the western boundary of the Site. From a wetlands area east of the Site, an Unnamed Tributary runs across the southern portion of the site from east to west and empties into Sauquoit Creek. A seasonally wet unnamed drainage ditch runs parallel to where the pole building use to be and then cuts west across the Site, draining into the Sauquoit Creek. Sauquoit Creek likely acts as the local discharge area for groundwater at and in the vicinity of the Site. Groundwater is present at the Site in the overburden

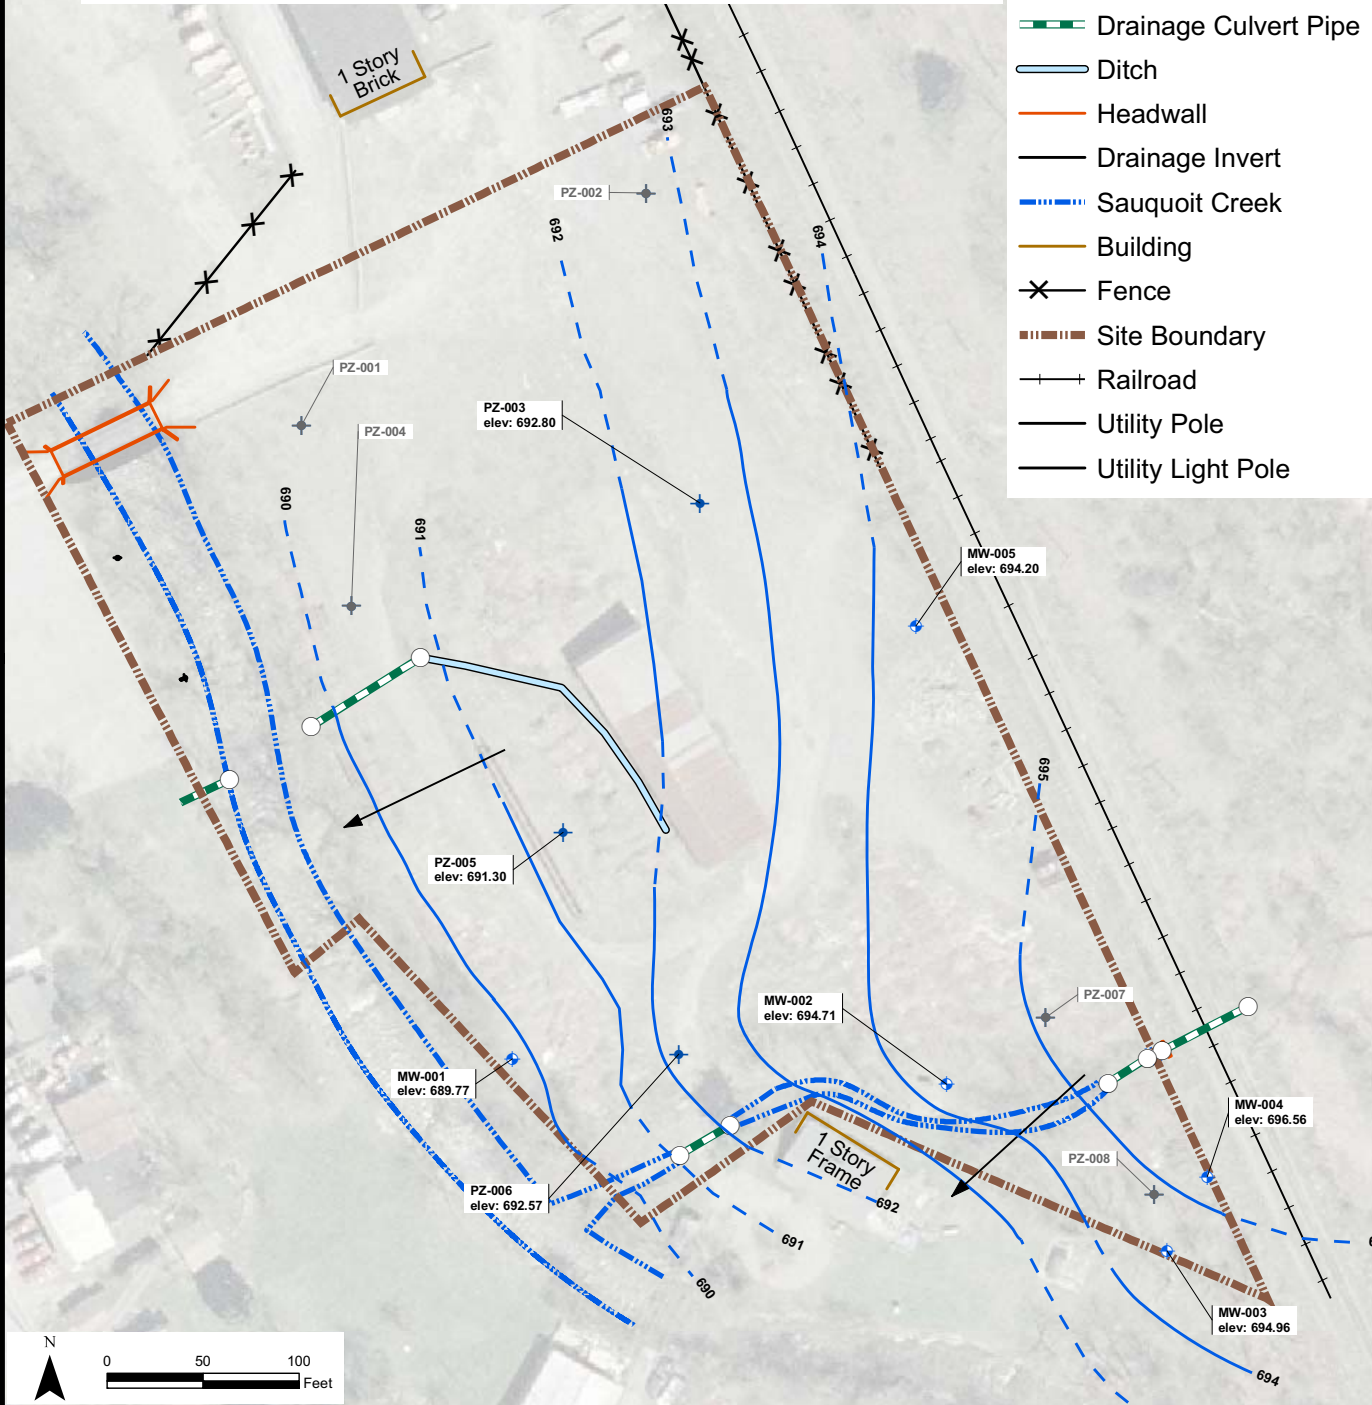
aquifer at depths of one to eight feet. Groundwater flows west across the Site toward the Sauquoit Creek, and groundwater flow in the immediate vicinity of the Unnamed Tributary appears to be influenced by the Unnamed Tributary. Groundwater contours are shown on Figure 3.

Notes: Groundwater Elevations measured by MACTEC on 3/19/08.  
 Survey performed for MACTEC by: Om P. Popli, PE LS PC  
 Consulting Engineers & Surveyors, 555 Penbrooke Drive, Penfield, New York 14526  
 Oneida County color digital orthoimagery (2003) obtained from New York State  
 GIS Clearinghouse at: <http://www.nysgis.state.ny.us>

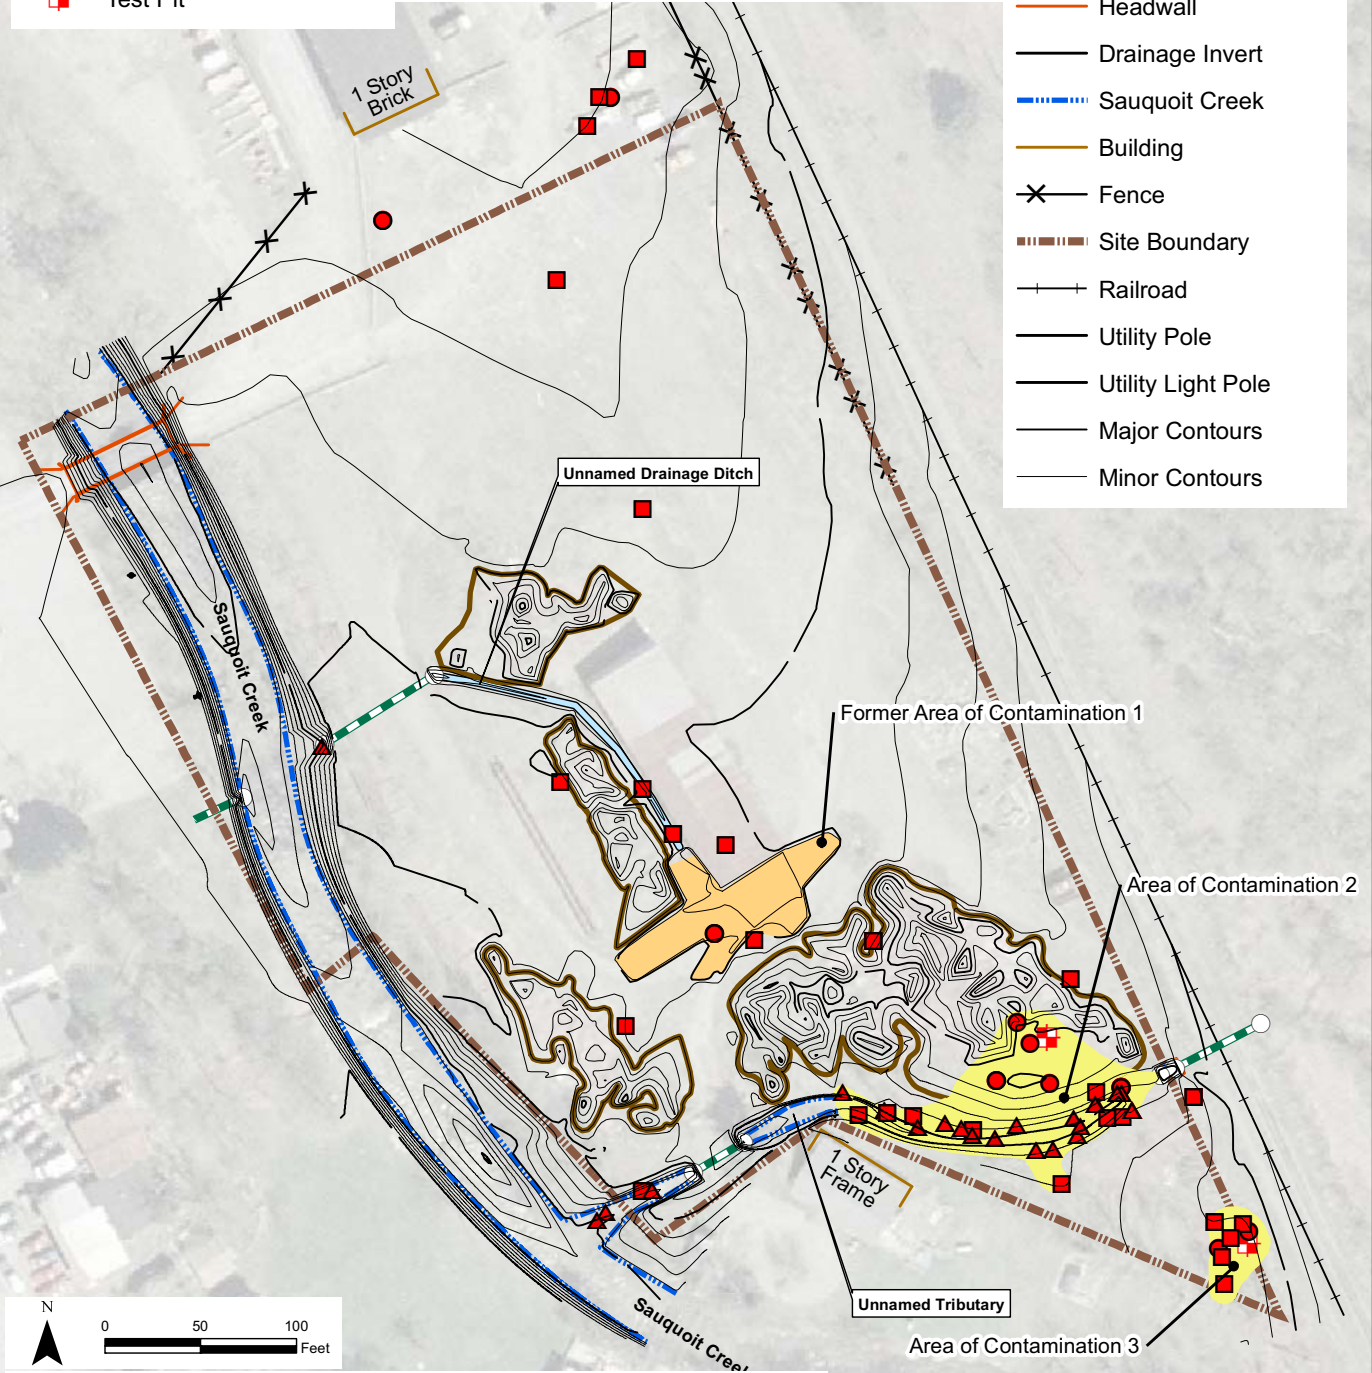
Figure 4 shows three primary PCB Areas of Contamination (AOCs) at the site. These AOCs have been delineated by PCB concentrations in excess of 10 ppm, and contain discrete areas of PCB contamination with concentrations in excess of the hazardous waste threshold of 50 ppm. AOC 1 consisted of PCB-contaminated soils located from 0 to 3 feet below grade in the central portion of the site and was addressed during an Interim Remedial Measure in November 2007. Confirmation sampling conducted during the IRM indicated a small amount of soil with PCB concentrations greater than 10 ppm remained at depths of greater than 3 feet following the completion of the IRM.

AOC 2 consists of approximately 2,000 cubic yards of PCB-contaminated soil, C&D debris and sediment located within and adjacent to the Unnamed Tributary, extending from near the upstream culvert to approximately one-half the distance to the Sauquoit Creek. Sampling indicates the vertical extent of PCB-contaminated soil in AOC 2 is approximately 9 feet below grade. AOC 3 consists of approximately 150 cubic yards of PCB-contaminated soil located in the southeastern corner of the Site. Sampling indicates the vertical extent of PCB-contaminated soil in AOC 3 is approximately 3 to 4 feet below grade.

- Estimated Extent of PCB Area of Contamination
- IRM Excavation Area (Former Area of Contamination 1)
- C&D Debris Piles

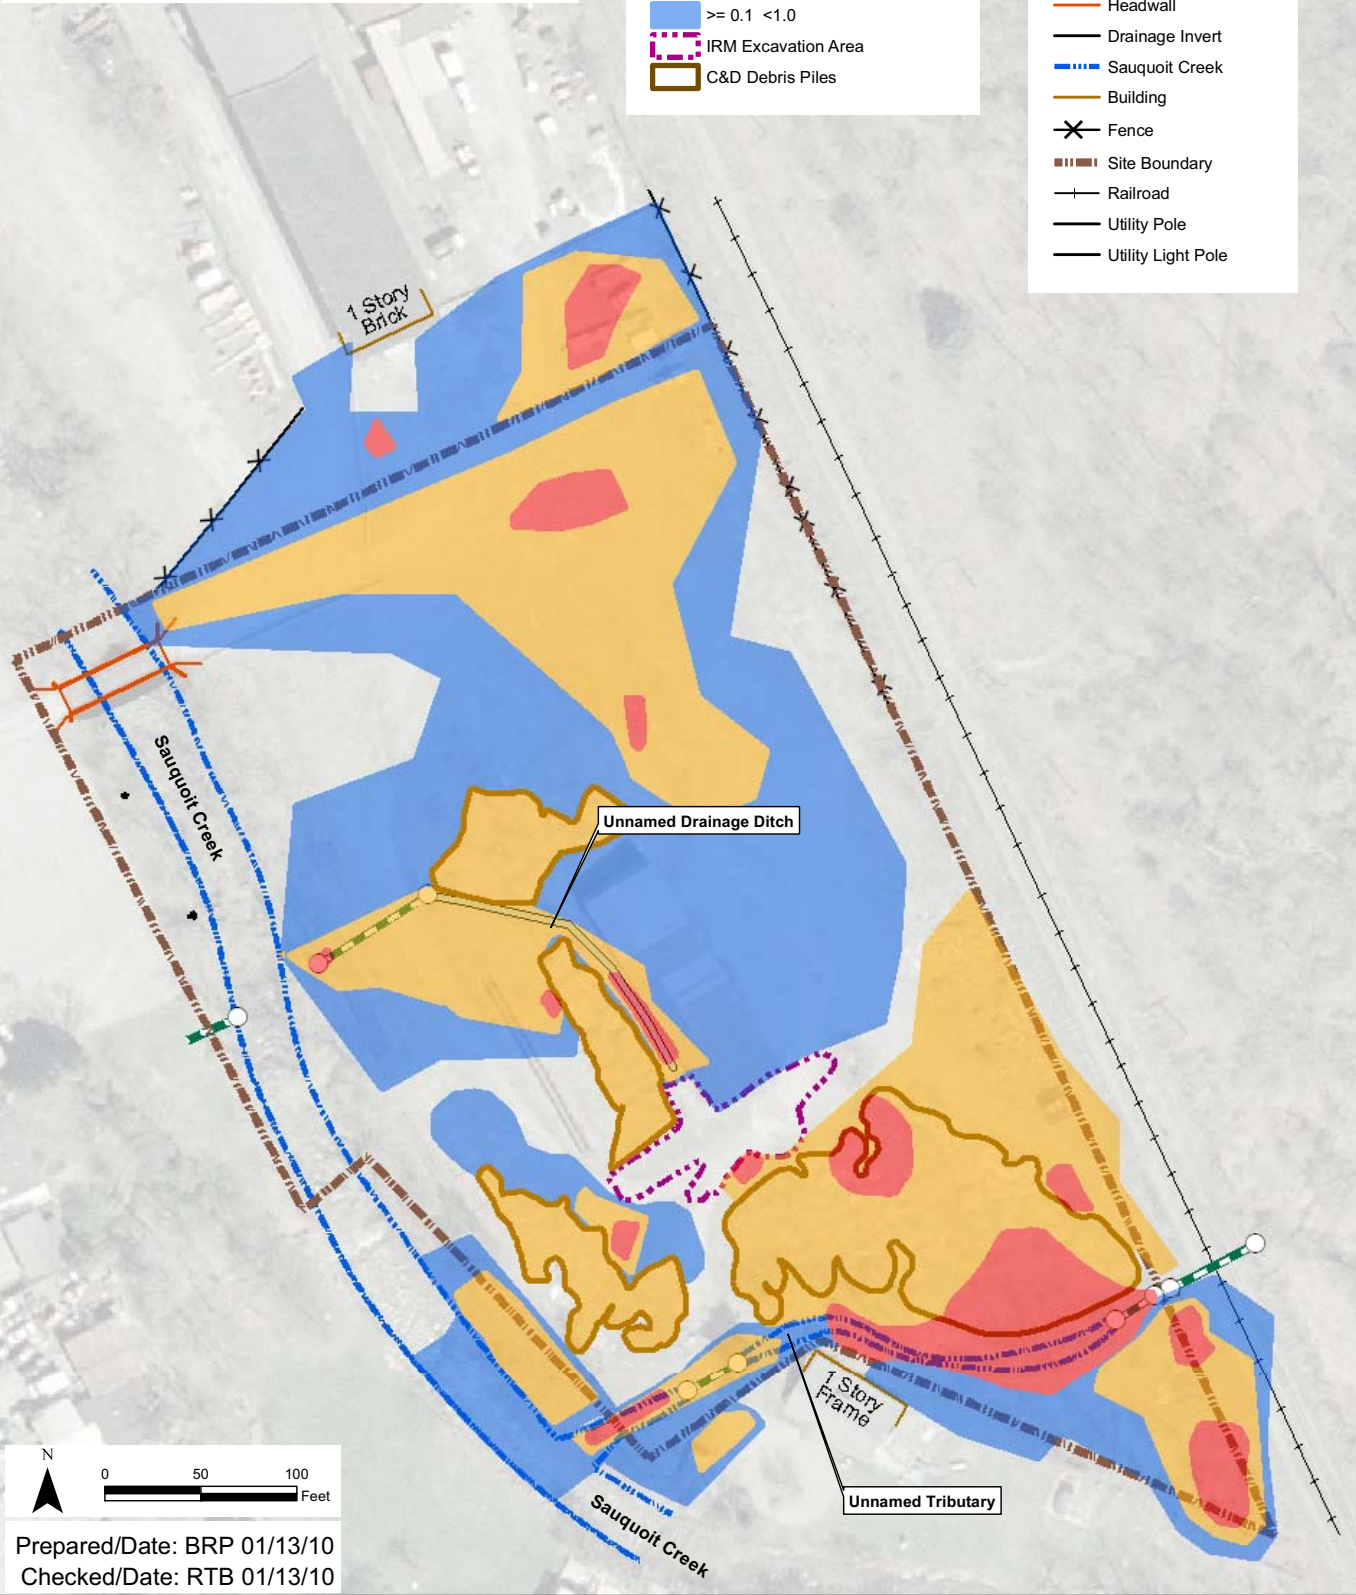
Figures 5 and 6 show exceedences of the unrestricted use SCO (0.1 ppm) and the residential use SCO for the protection of public health (1 ppm) for total PCB concentrations in soil samples. In surface and subsurface soil PCBs exceed 0.1 ppm over the majority of the site as well as portions of the adjacent off-site commercial property to the north and the residential property to the south. In general the vertical extent of PCBs exceeding 0.1 ppm (outside of C&D debris piles and AOCs shown on Figure 4) is limited to 2 feet.

Surface and subsurface soil concentrations of PCBs were delineated both on-site and off-site as shown on Figures 5 and 6. PCBs exceeding 1 ppm on the adjacent commercial property to the north of the site are limited horizontally to two discrete areas and vertically to 1 foot below grade in these areas. PCBs exceed 1 ppm on the adjacent residential property to the south of the site in a discrete area on the northern boundary of this property. On-site PCB concentrations exceeding 1 ppm are widespread in surface soils, but limited mostly to the southern half of the site in subsurface soils.

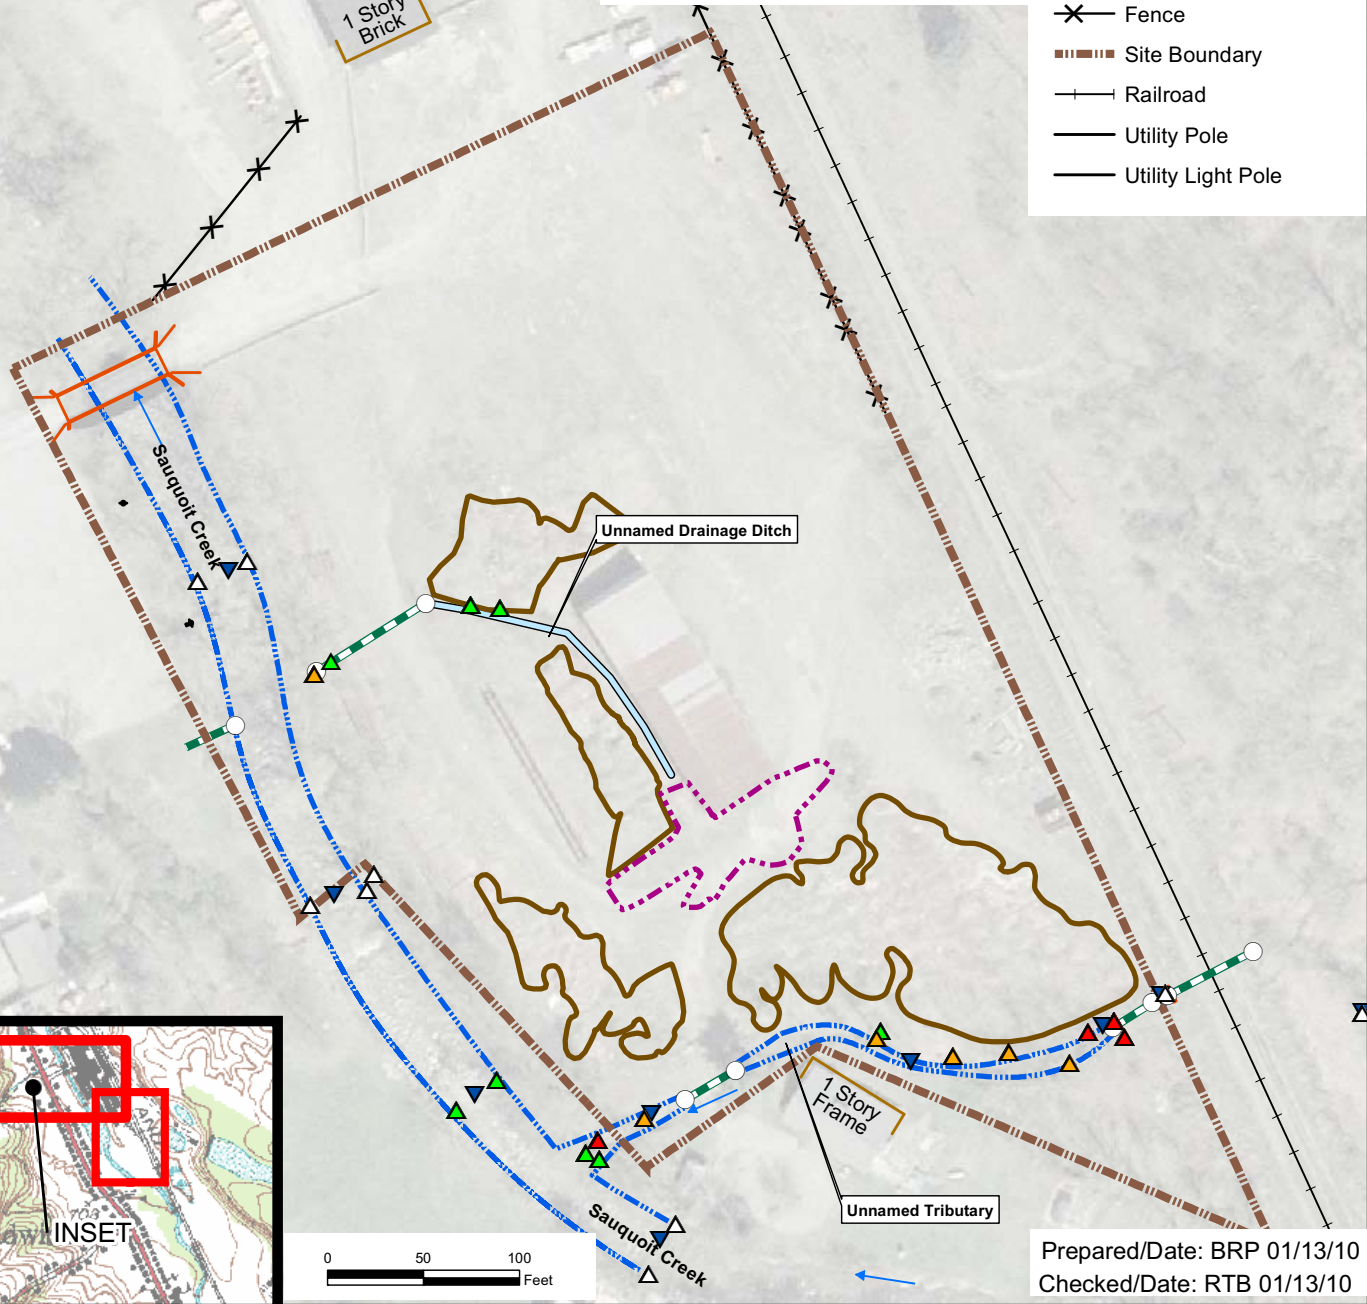
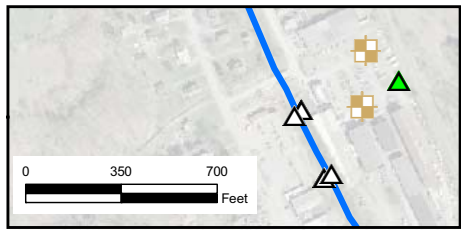
As shown on Figure 7, the highest concentrations of PCB contamination in sediments is located in the Trib in the southeast corner of the site. Concentrations were observed as high as 7,200 ppm in this area in sediment, which is the highest concentration of PCBs in any soil or sediment sample collected from the site. Subsurface sediment sampling indicated PCBs exceeding SCGs may extend greater than 2 feet below grade. Concentrations of PCBs are present that exceed SCGs in sediments along the entire length of the Trib as it passes through the site. Sediment from the Trib has impacted Sauquoit Creek sediment in the vicinity of the Trib's outlet to the Creek.

<b>Sediment Contamination</b>	IRM Excavation Area
▲ PCBs >= 50 mg/Kg	C&D Debris Piles
▲ PCBs >= 10 mg/kg < 50 mg/kg	○ Drainage Invert
▲ PCBs < 10 mg/Kg	— Bridge
△ PCBs Non-Detect	— Bridge Guide Rail
■ Catch Basin Sediment Sample	— Drainage Culvert Pipe
▼ Surface Water Sample Location	— Ditch
	— Headwall
	— Drainage Invert
	— Sauquoit Creek
	— Building
	✕ Fence
	— Site Boundary
	— Railroad
	— Utility Pole
	— Utility Light Pole

Concentrations of PCBs found in site sediments are several orders of magnitude greater than SCGs in most cases. PCB concentrations found in sediment exceed the hazardous waste threshold for PCBs of 50 ppm in the Trib. Exceedences of SCGs for SVOCs in sediment are characteristic of typical urban runoff and/or runoff from non-hazardous C&D debris piles. Most exceedences of SCGs for SVOCs in sediments are co-located with exceedences of SCGs for PCBs in sediments or near a storm water runoff outfall.

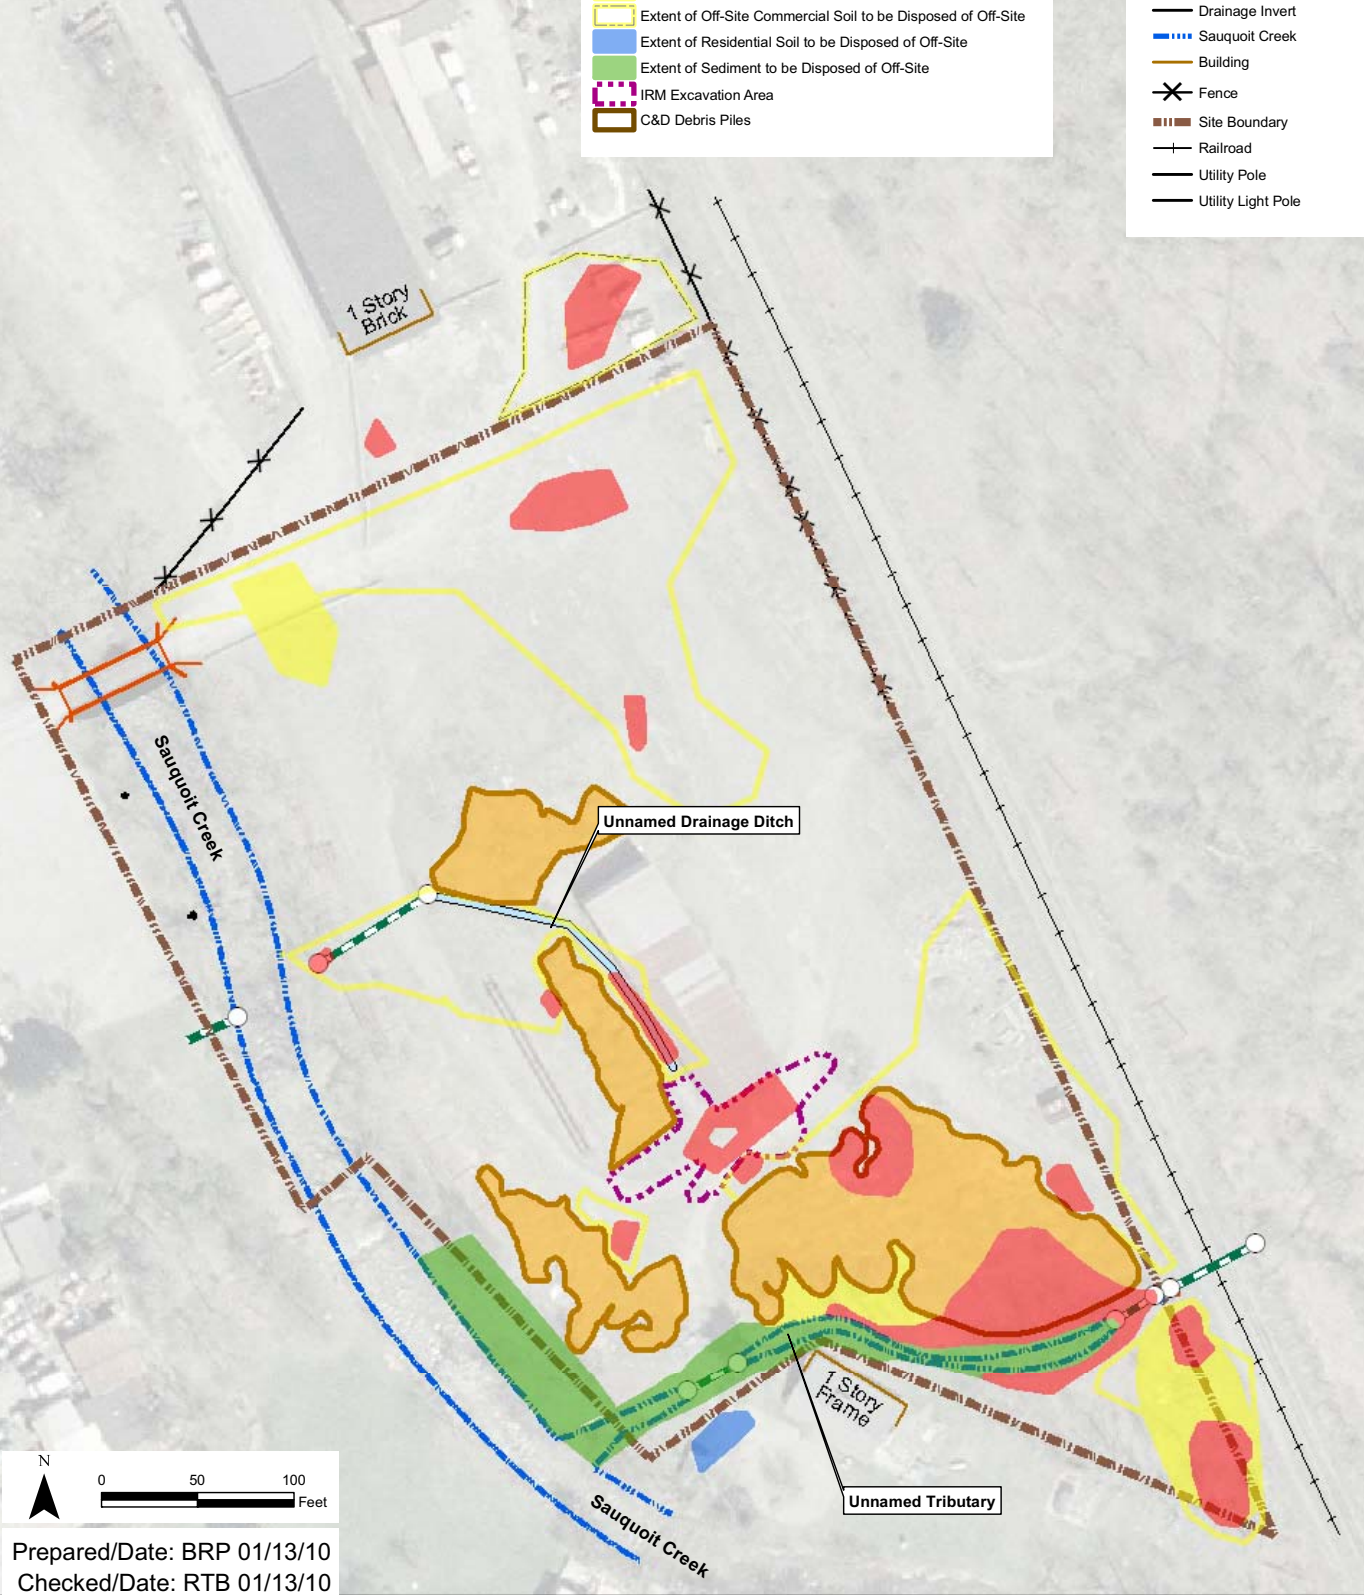
Selected Remedy  
 3650-07-0089  
 Figure 8

1. A remedial design program will be implemented to provide the details necessary for the construction and monitoring of the remedial program.
2. Excavation and off-site disposal at a permitted facility of contaminated soil, sediment and C&D debris from on-site areas (including the Trib and Ditch), as well as off-site areas including the Sauquoit Creek East Bank and two adjacent off-site properties where contamination has migrated. The areas to be excavated are shown on Figure 8. Confirmatory soil samples will be collected to assure the excavation allows for residential use of the site and surrounding areas. The areas to be excavated include:
